Manhole Inspection Summary

Manhole # S15AA_018MH

Location Address: **REAR 1001 ASHBURTON ST**

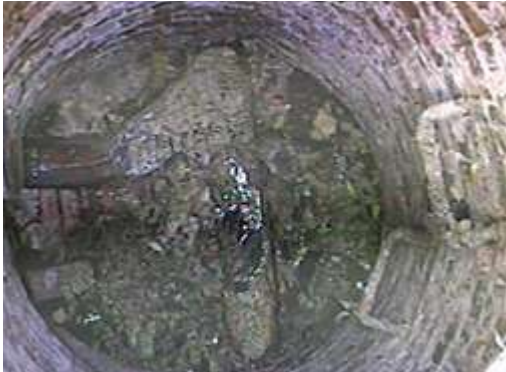
Defect 1

Condition: ☐ Sound ☐ Cracked ☐ Root Intrusion ☐ Deteriorated ☐ Leaks ☒ **Debris**

Channel and Bench condition debris

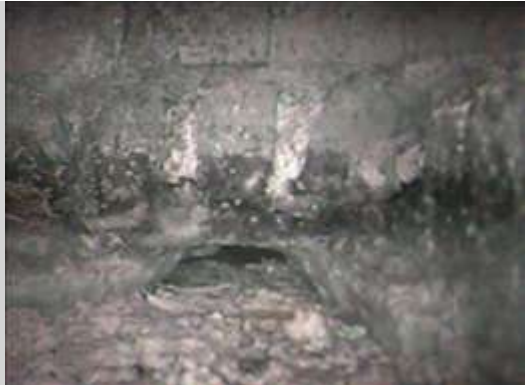
12 O'Clock Outflow

8 in. Circular Gravity Sewer
Pipe Out @ 12 O'Clock

Pipe Height: (in.) Direct
Pipe Material: **Clay** ☐ Pipe Lined
Invert Depth: **9.26** (ft.) Flow Characteristics: **Slow**
Deposits: ☐ None ☒ Mud ☒ Sludge ☒ Debris ☒ Grease
Silt Depth: **5** (in.) Deposits Extent: **Heavy**
Infiltration: **None** Pipe Seal Cond: **Sound**

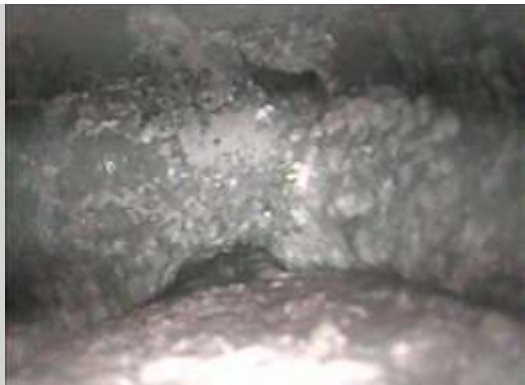
6 O'Clock Inflow

8 in. Circular Gravity Sewer
Pipe In @ 6 O'Clock

Pipe Height: (in.) Direct
Pipe Material: **Clay** ☐ Pipe Lined
Invert Depth: **9.12** (ft.) Flow Characteristics: **Slow**
Deposits: ☐ None ☒ Mud ☒ Sludge ☒ Debris ☒ Grease
Silt Depth: **5** (in.) Deposits Extent: **Heavy**
Infiltration: **None** Pipe Seal Cond: **Sound**

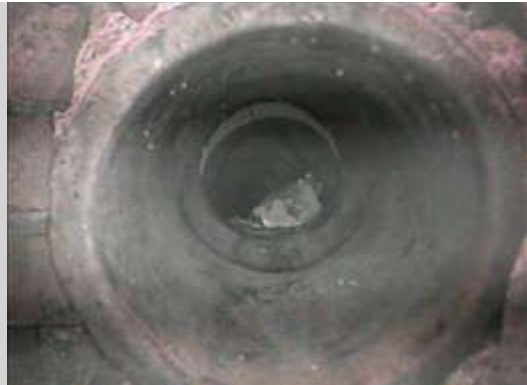
9 O'Clock Inflow

Pipe In @ 9 O'Clock

Invert Depth: **6.75** (ft.) Flow Characteristics: **Slow**

Deposits: ☒ None ☐ Mud ☐ Sludge ☐ Debris ☐ Grease

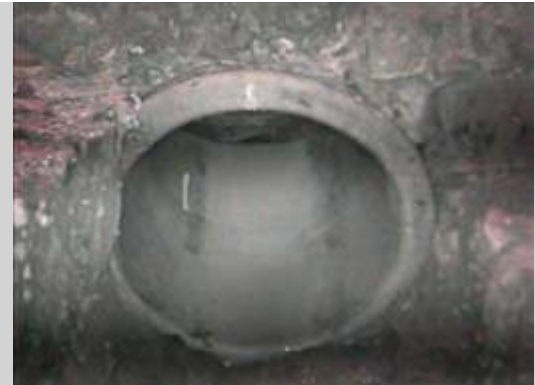
Drop In @ 9 O'Clock

Drop: **Inside** **Direct**

Inv Depth: **8.42** (ft.)

Drop Condition: **Open**
